Manhole Inspection Summary

Manhole # S33YY1005MH

Insp Date: **1/30/07 8:24 AM**

Location Address: **207 WITHERSPOON RD**

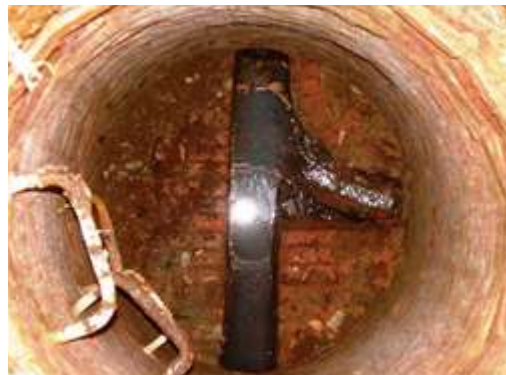
Top View

Corroded steps. Bench debris.

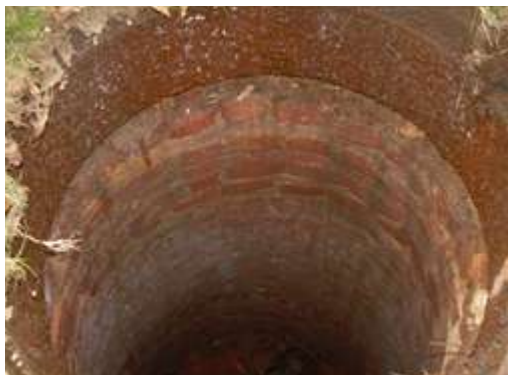
Defect

Frame offset. Frame offset. Adjustment deterioration, root intrusion, and infiltration. Corbel and Barrel infiltration -

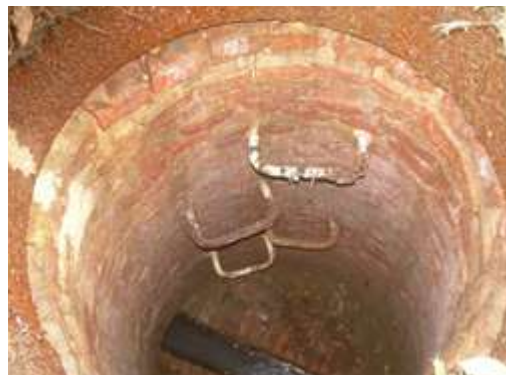
Defect

Frame offset. Adjustment deterioration and infiltration. Corbel and Barrel infiltration.

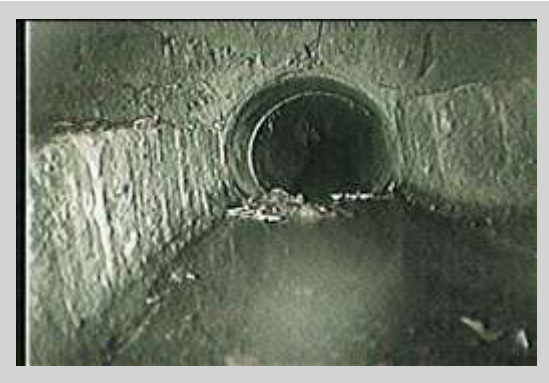
8 in. Circular Gravity Sewer Pipe Out @ 12 O'Clock

Deposits: ☐ None ☒ **Mud** ☐ Sludge ☒ **Debris** ☐ Grease

Infiltration: **Evidence** Pipe Seal Cond: **Cracked**

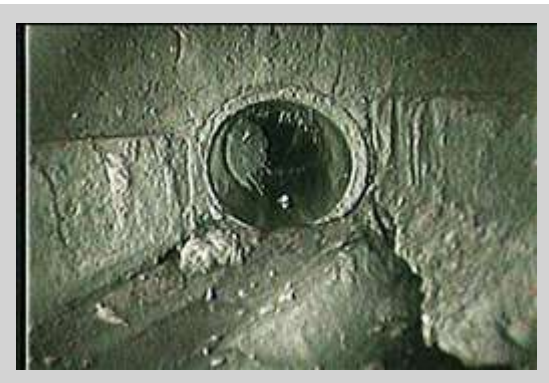
6 in. Circular Gravity Sewer Pipe In @ 3 O'Clock

Channel deterioration.

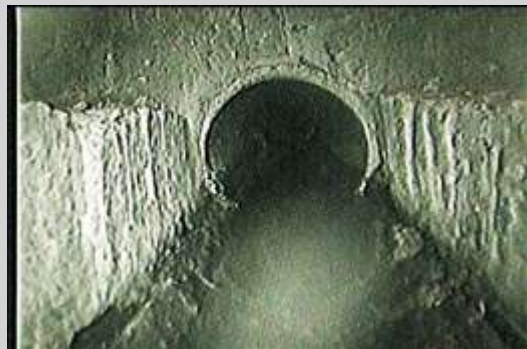
Pipe In @ 6 O'Clock

Channel deterioration.
